Jun 30th, 2026

2601 HWY 64 West, Shelbyville, TN, 37160

# Inspection Report

• Building Type Commercial

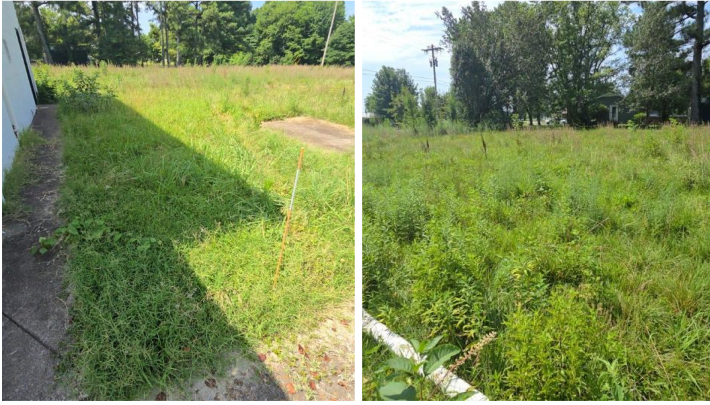
**Location** - Landscaping

The lot surrounding the building was noted to be severely overgrown. The inspector tripped on a deep trench that was hidden by overgrowth. The client, architect, and HVAC inspector all tripped and fell on this same hidden hole. It is likely that there are other trip hazards being hidden by the lot being so overgrown.

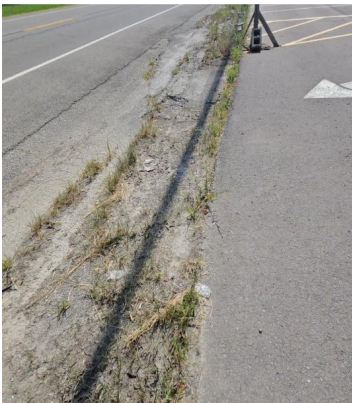
Location - Parking lot

Evidence of pooling rainwater.

The grade of the parking lot sheds rainwater away from the structure, but evidence of pooling water at the entrance of the parking lot is evident.

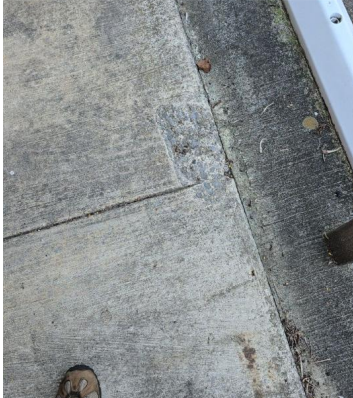
**Location -** Front of building

Damaged or deteriorated. Recommend that a qualified contractor evaluate and estimate repairs.

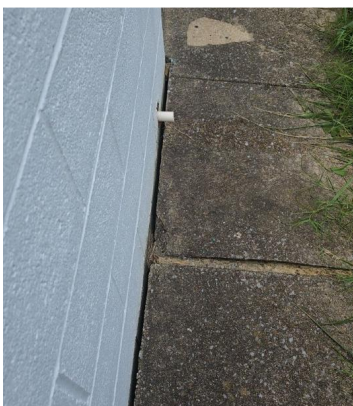
**Location -** Walkway

Settling causing uneven surface

The walkway is notably settling away from the structure. Evaluation by a qualified technician or structural engineer recommended.

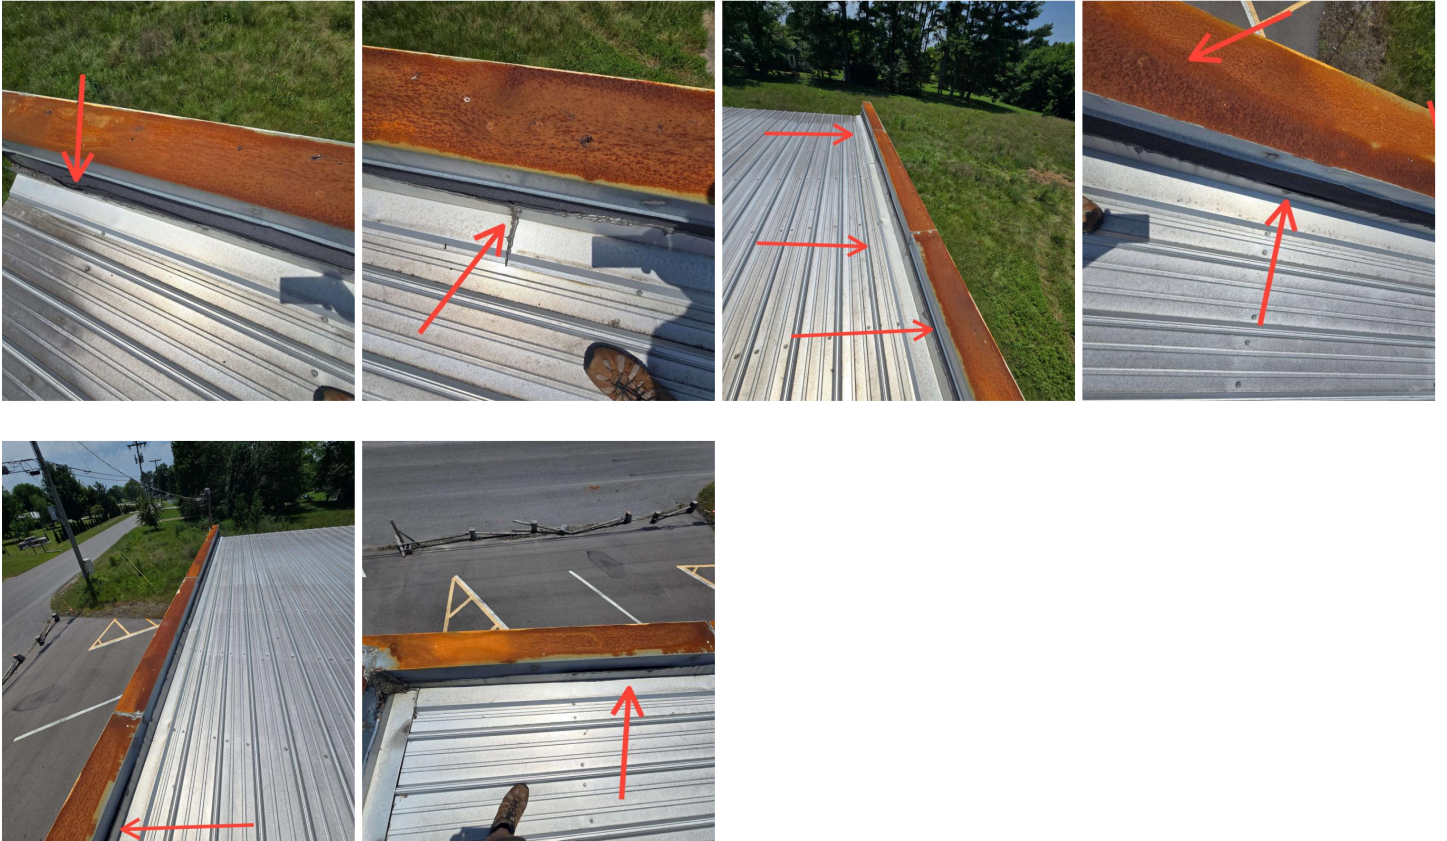
Location - Roof

Large areas of the parapet coping were noted to be rusted. Several areas of open or deteriorated sealant beneath portions of the coping/flashing were noted as well.

Recommend that a qualified contractor evaluate and estimate repairs

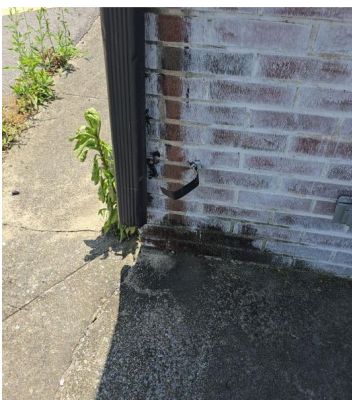
**Location** - Front of building

Loose downspout and missing leader

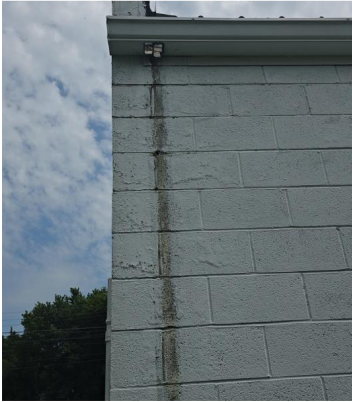
Location - Rear of building

## Downspout not installed

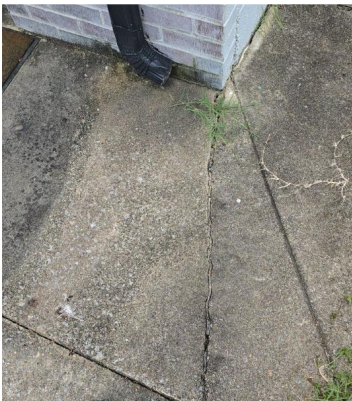
Location - Downspout

### Evidence of improper drainage

All rainwater should be pushed 6 feet from the structure to prevent future foundation issues.

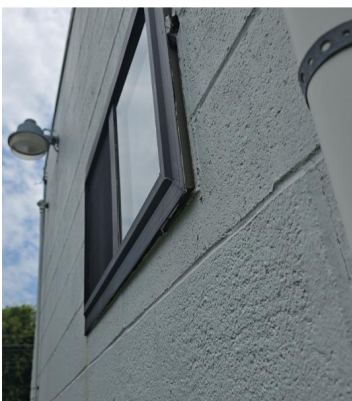
Location - Side of building

Loose window noted. Evaluation by a qualified technician recommended.

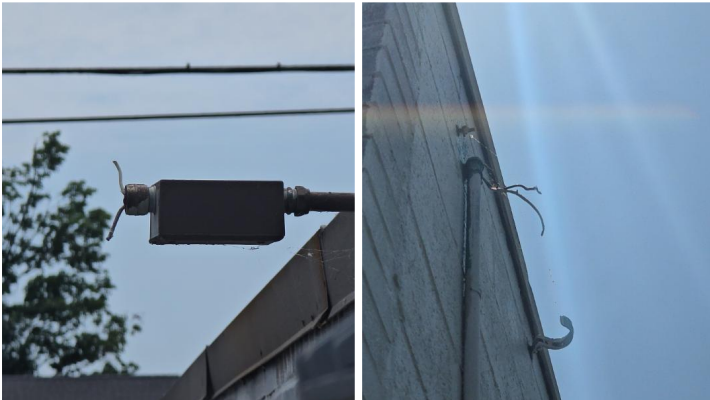
**Location** - Exterior of building

### Exposed wiring/missing lights

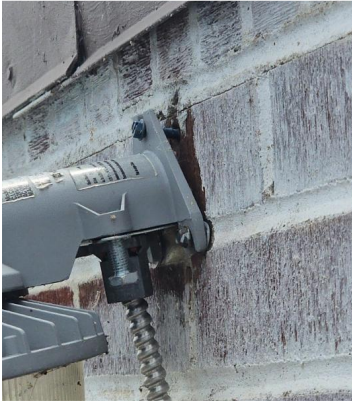
**Location** - Front of building

### Improperly mounted

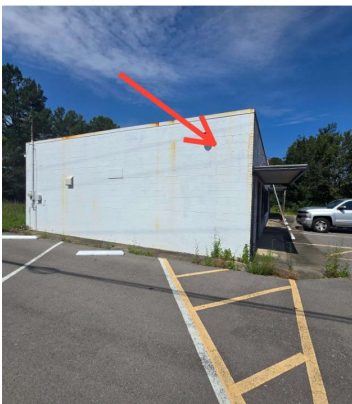
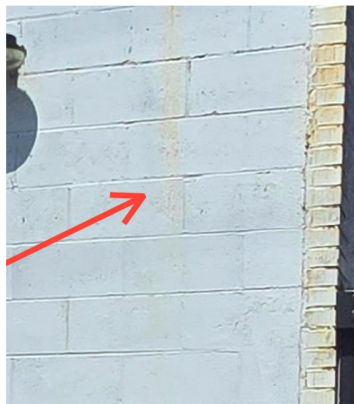
**Location** - Side wall near front entry

Minor spalling noted on the face of the cinder block

Evaluation by a qualified technician or structural engineer recommended.

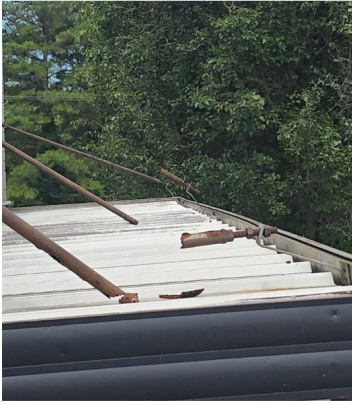
**Location** - Front of building

Canopy hanger rods noted to be broken.

Replacement of the hanger rods of both overhangs recommended.

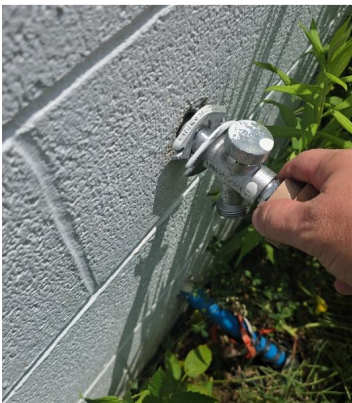
Location - Rear of building

Hose bib not attached to the structure

Attaching recommended to prevent accidental plumbing damage

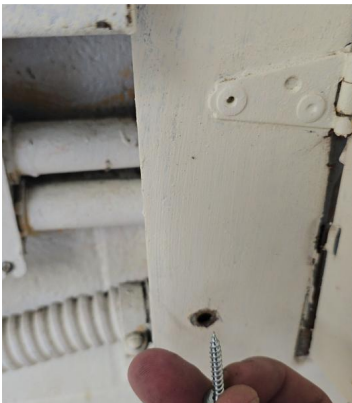
Location - Main panel

Incorrect screws used for panel cover

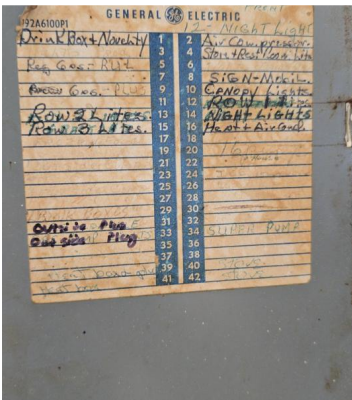
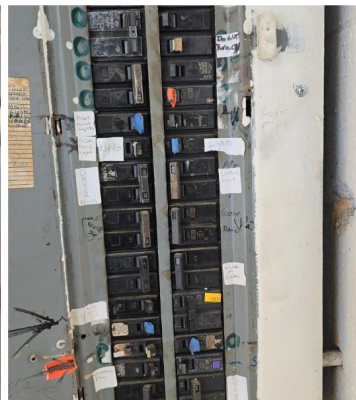
Location - Main panel

Breaker(s) labeling is inadequate

Evaluation and repair by a qualified electrician recommended.

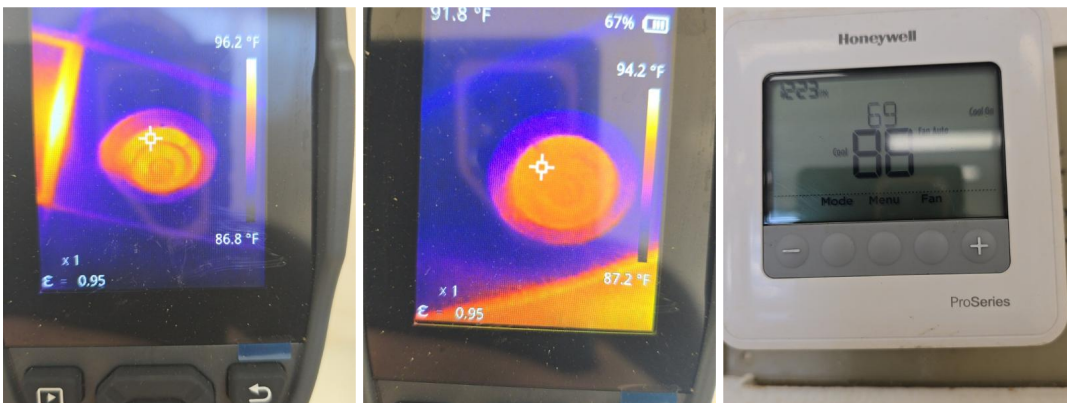
Location - HVAC system

Thermostat was set at 69 degrees and the "conditioned" air was noted to be coming out at 92 degrees

Recommend that a qualified contractor evaluate repairs/replacement

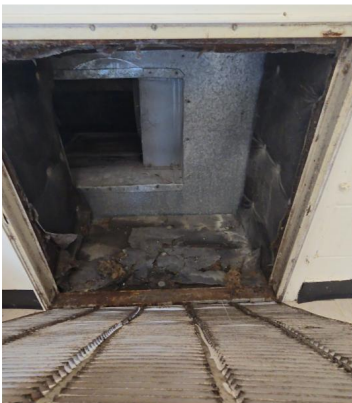
Location - HVAC return

Missing filter

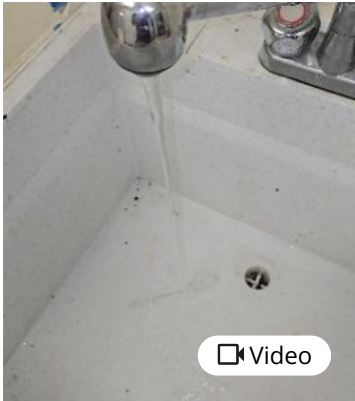
## Location - Utility sink

Poor water pressure noted

Evaluation by a qualified plumber recommended.

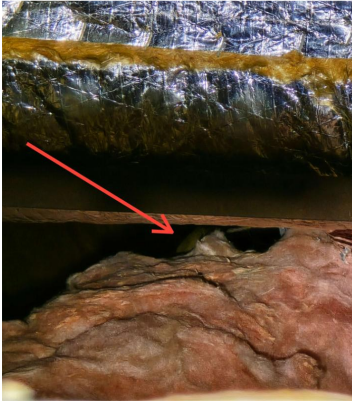
Location - Ceiling

A rodent was noted in the suspended ceiling

The presence of one rodent is usually indicative of more rodents. Evaluation by a qualified technician recommended.

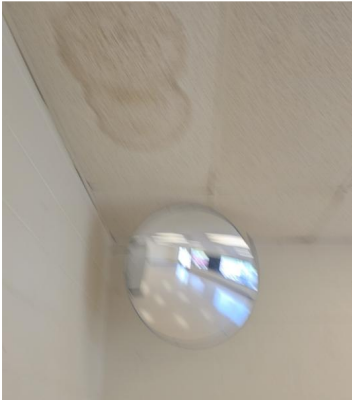
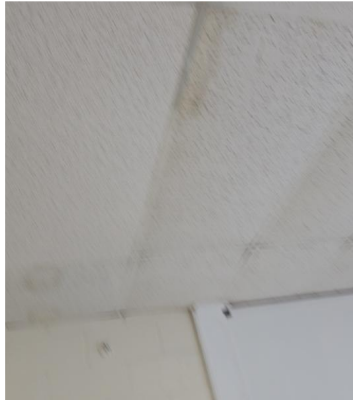
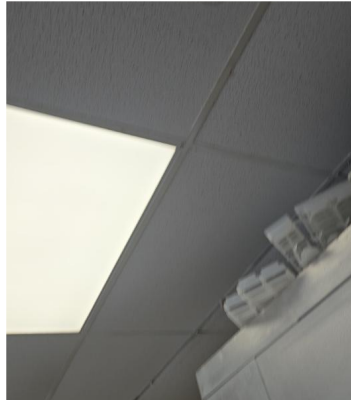
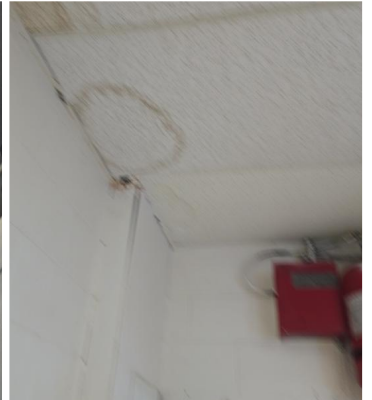
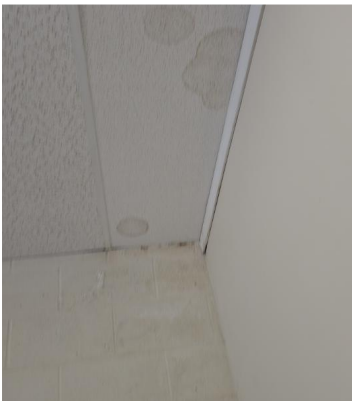
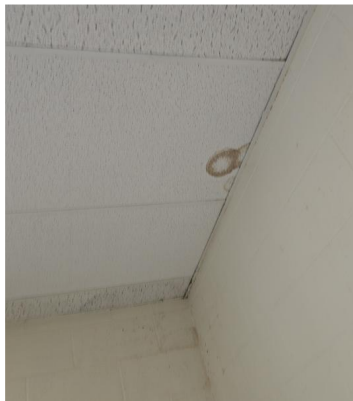
### Location - Ceiling

## Evidence of past or present water damage

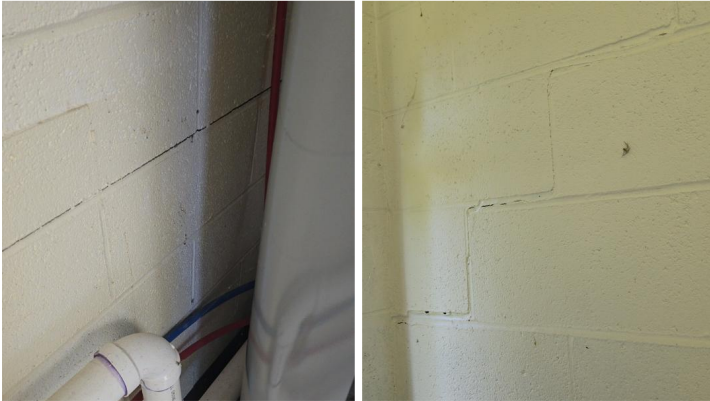
Location - Interior

Evaluation by a structural engineer recommended

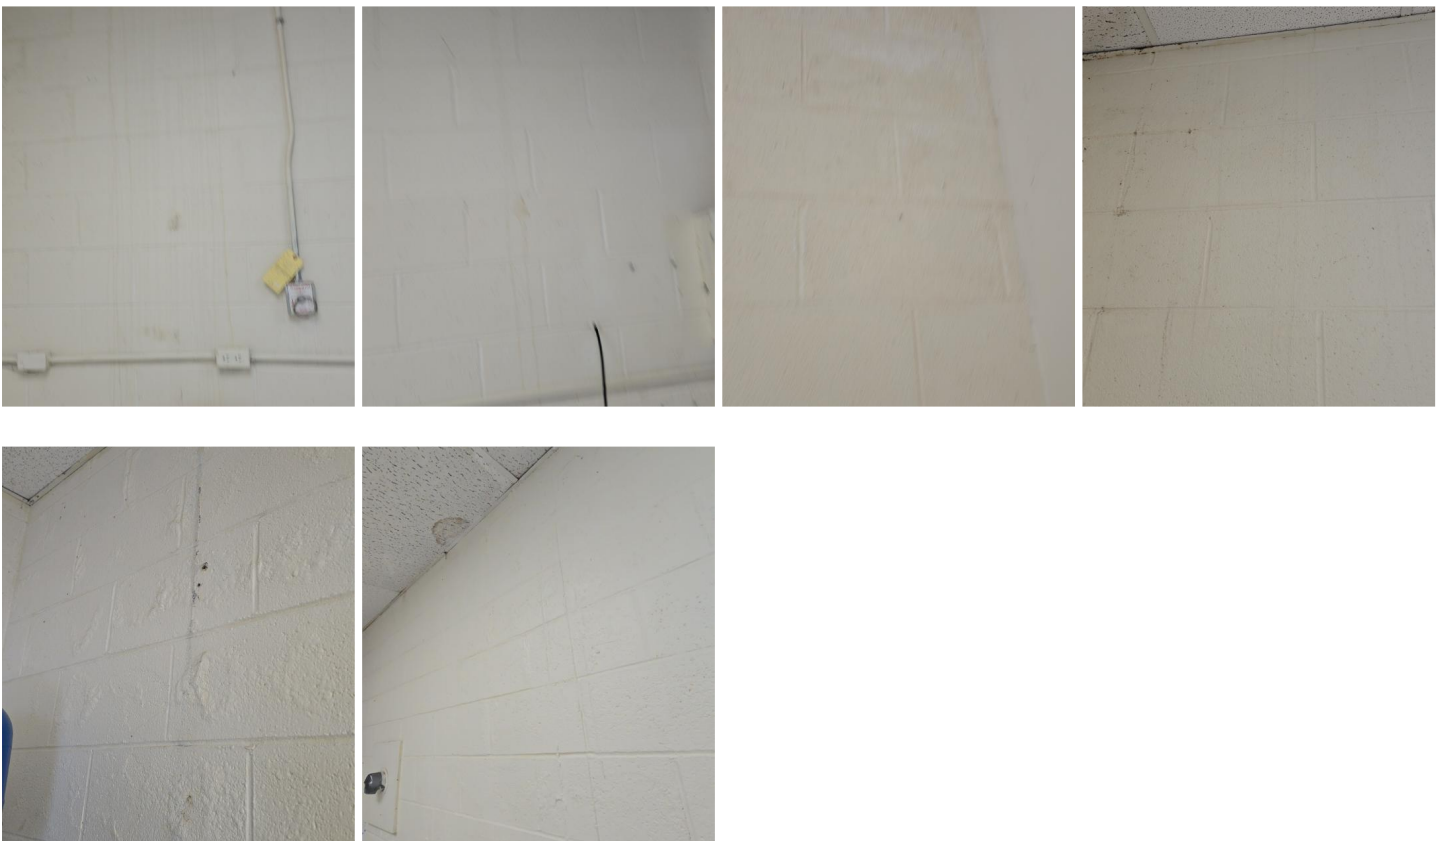
Location - Interior

Evidence of past or present water intrusion

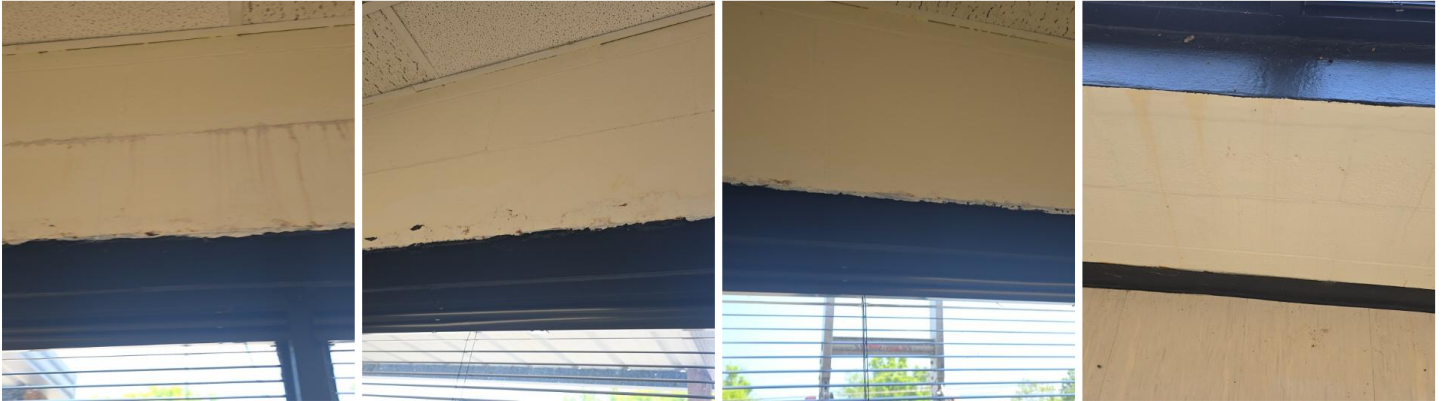
Location - Main room

Evidence of past or present water damage

Evaluation by a structural engineer recommended to ensure the structural integrity of the concrete header.

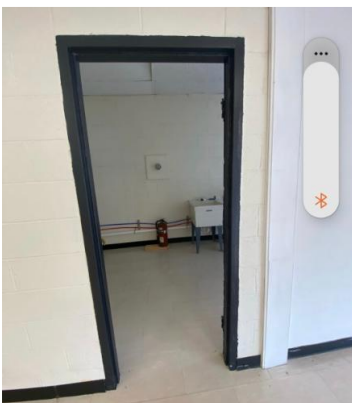
Location - Interior

Replace missing door(s)

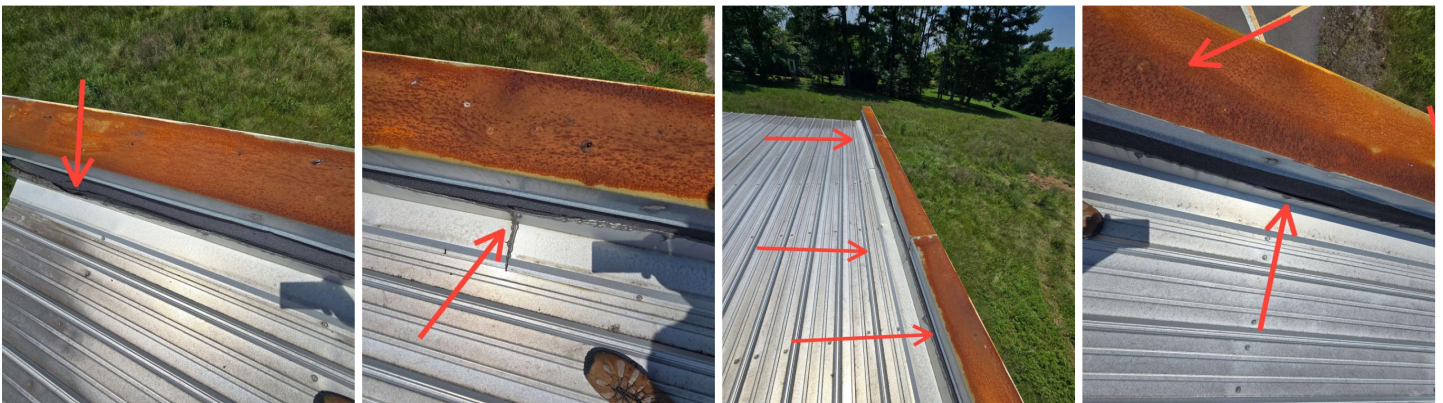
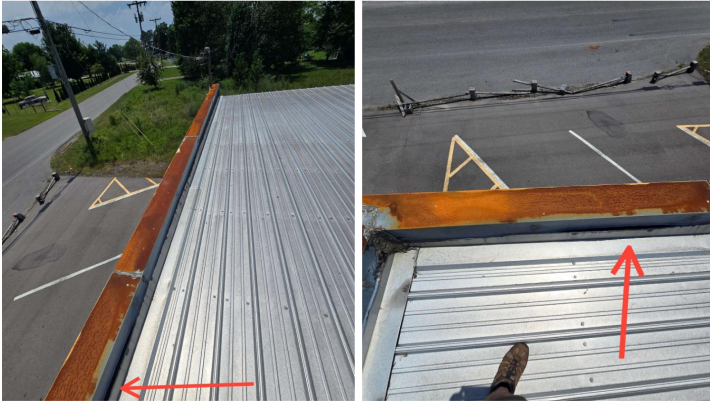
Location - Roof

Large areas of the parapet coping were noted to be rusted. Several areas of open or deteriorated sealant beneath portions of the coping/flashing were noted as well.

Recommend that a qualified contractor evaluate and estimate repairs

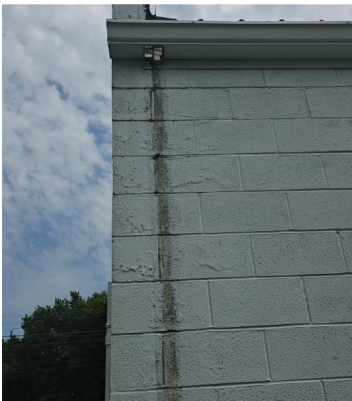
Location - Rear of building

Downspout not installed

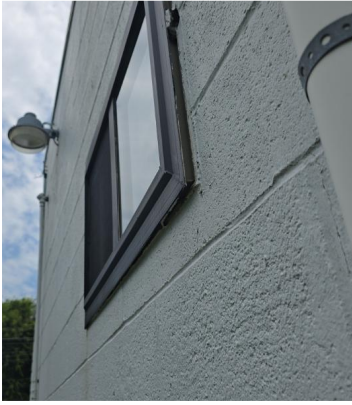
Location - Side of building

Loose window noted. Evaluation by a qualified technician recommended.

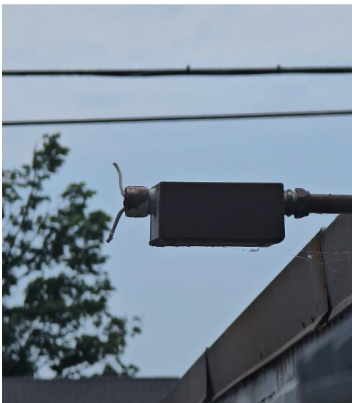
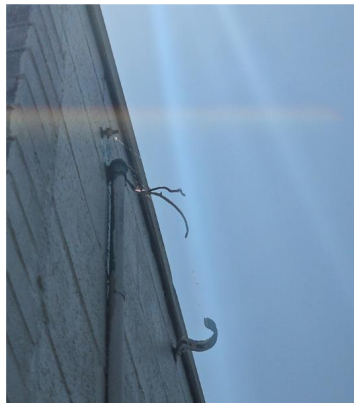
Location - Exterior of building

Exposed wiring/missing lights

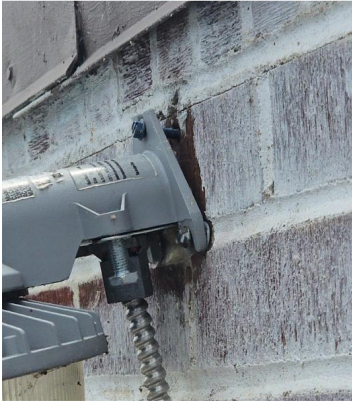
Location - Front of building

Improperly mounted

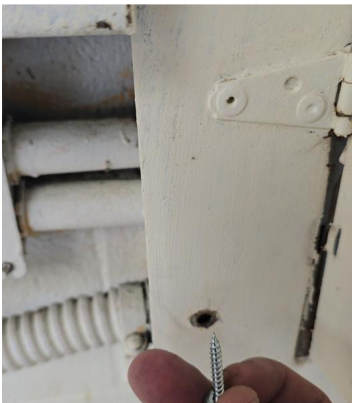
Location - Main panel

Incorrect screws used for panel cover

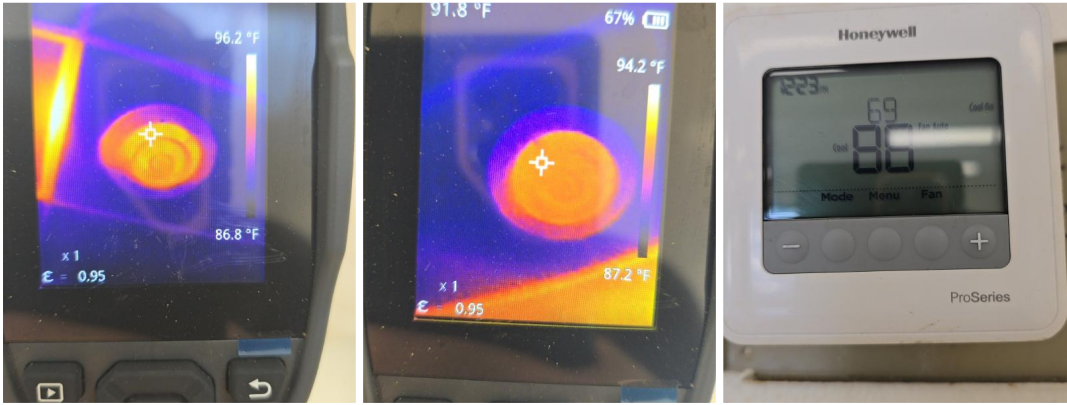
Location - HVAC system

Thermostat was set at 69 degrees and the "conditioned" air was noted to be coming out at 92 degrees

Recommend that a qualified contractor evaluate repairs/replacement

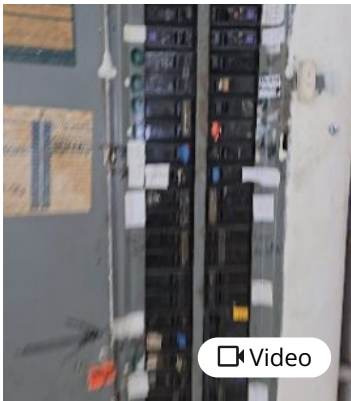
Location - Main panel

Outlet was noted to short when tested.

Evaluation by a qualified electrician recommended.

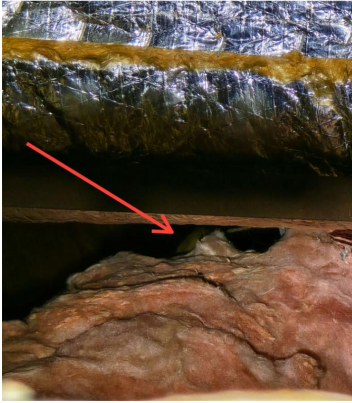
Location - Ceiling

A rodent was noted in the suspended ceiling

The presence of one rodent is usually indicative of more rodents. Evaluation by a qualified technician recommended.

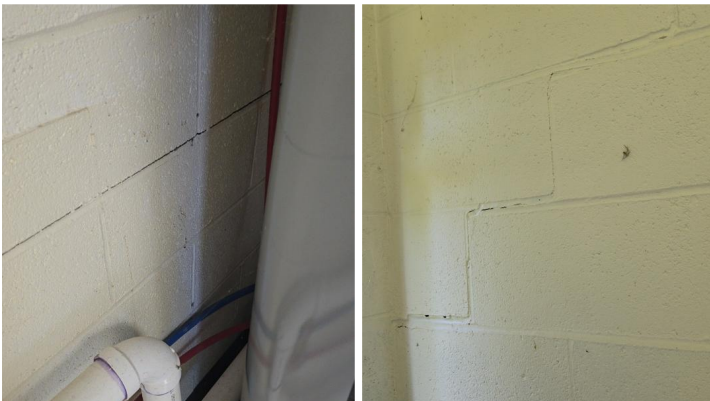
Location - Interior

Evaluation by a structural engineer recommended

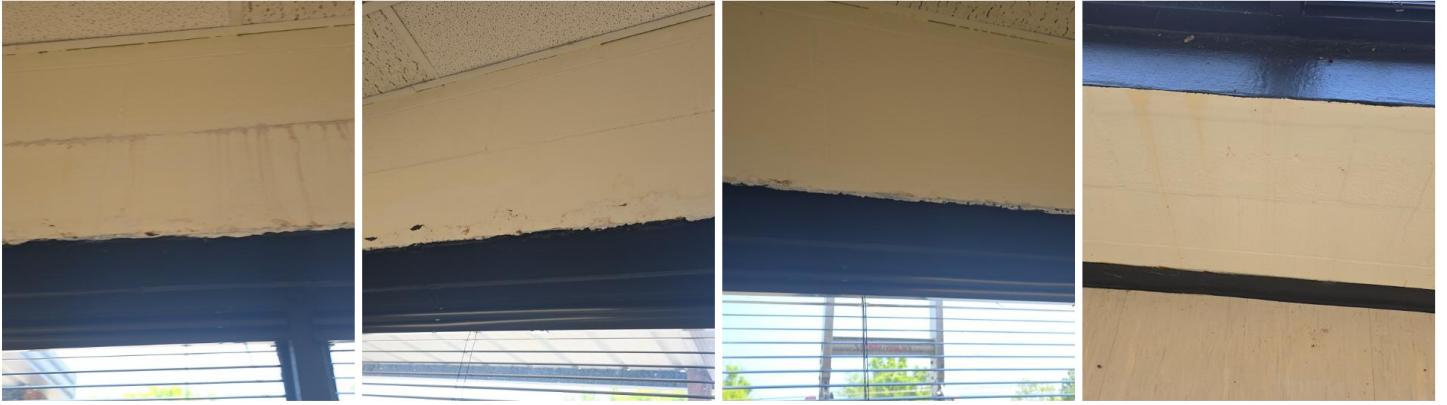
Location - Main room

Evidence of past or present water damage

Evaluation by a structural engineer recommended to ensure the structural integrity of the concrete header.
