Jun 30th, 2026

2601 HWY 64 West, Shelbyville, TN, 37160

# Inspection Report

• Building Type Commercial

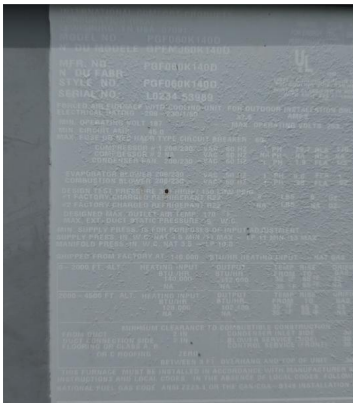
Model number - PGF060K140D

Thermostat was set at 69 degrees and the "conditioned" air was noted to be coming out at 92 degrees

Recommend that a qualified contractor evaluate repairs/replacement
